**Flood Control Project Maintenance  
Levee Inspections****LMA District Cover Sheet****Spring 2013 Levee Inspection Results****Reclamation District No. 0150 Merrit Island**

**Spring 2013 Levee Inspection Results**

**Reclamation District No. 0150 Merrit Island**

Waterway			Bank	Unit Miles
Unit No. 01 Sutter Slough			Left	0.54
	Spring (March - May)	Summer (June - August)	(September - November) Fall	Winter (December - February)
Unit Maintenance Rating (Fall Only)				
Date of Inspection	03/14/2013 - 03/14/2013			
DWR Inspector	Pavel Kazi			
Accompanied By

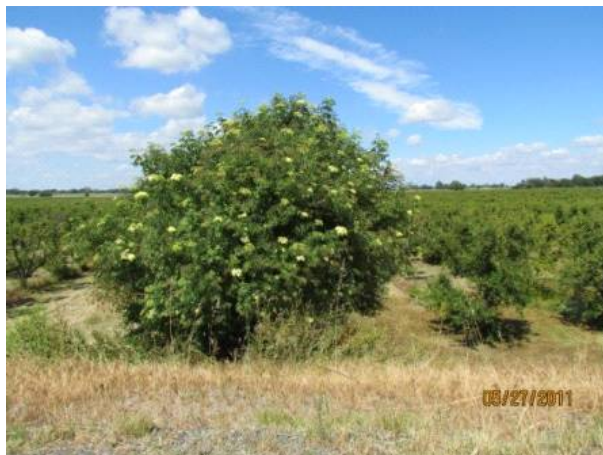
Levee Mile Report Line	5
Start Levee Mile	0.20
End Levee Mile	0.20
Location	Land Side
Category	
Item	Vegetation
Elderberry bush was found on the landside of the levee. The picture was taken from the crown looking downstream.	
pkazi_s_20130304_523.jpg

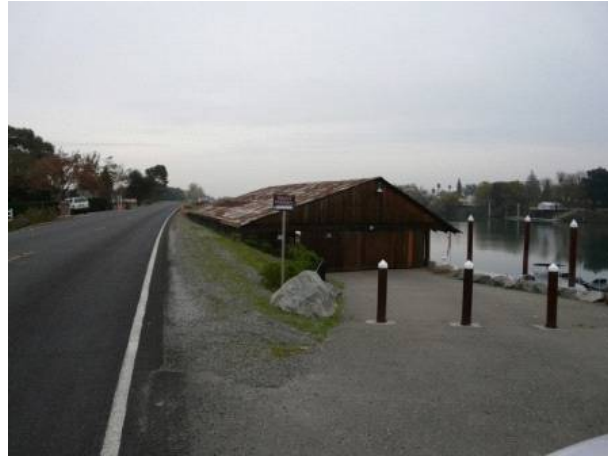
Levee Mile Report Line	2
Start Levee Mile	0.16
End Levee Mile	0.16
Location	Water Side
Category	
Item	Encroachments
Building located on waterside of levee at LM 0.16	
pkazi_s_20130304_551.JPG

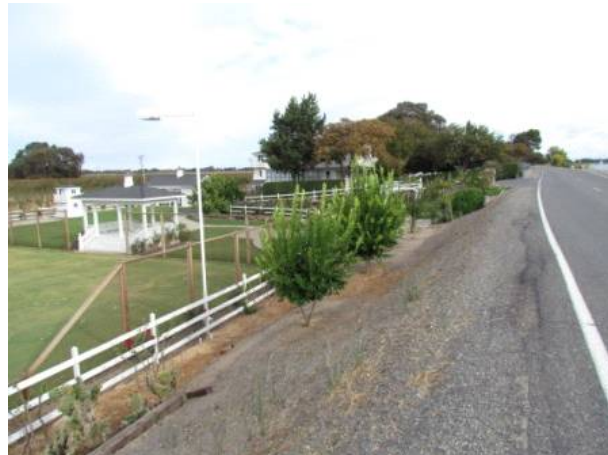
Levee Mile Report Line	3
Start Levee Mile	0.17
End Levee Mile	0.21
Location	Land Side
Category	
Item	Vegetation
Landscaping was found on the landside of the levee looking upstream.	
pkazi_s_20130304_576.jpg

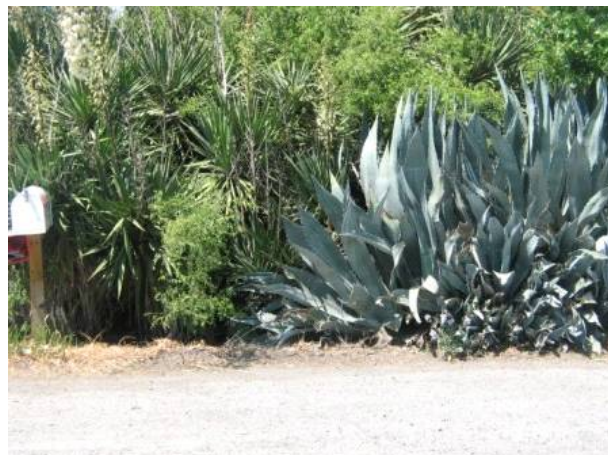
Levee Mile Report Line	4
Start Levee Mile	0.25
End Levee Mile	0.25
Location	Land Side
Category	
Item	Vegetation
Landscaping on landward slope at LM 0.25 blocking view of levee slope.	
pkazi_s_20130304_525.jpg

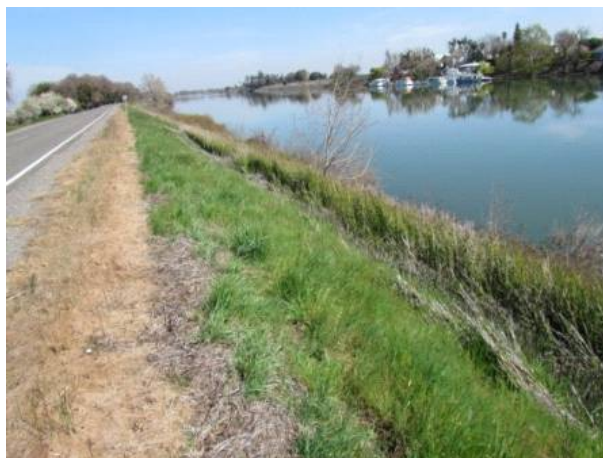
pkazi\_s\_20130319\_900.JPG

Vegetation was found on the waterside slope of the levee looking upstream during the spring 2013 inspection.

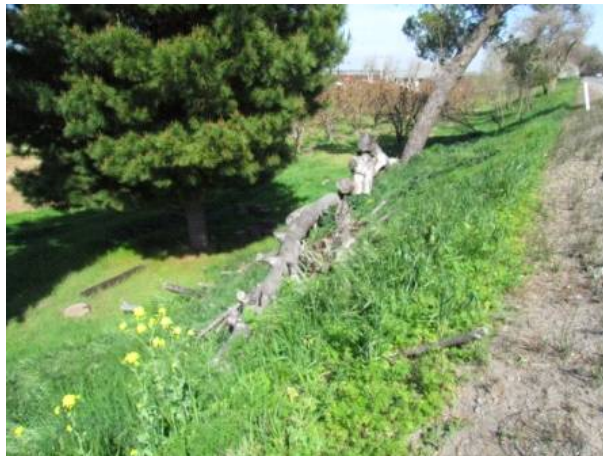
Levee Mile Report Line	6
Start Levee Mile	0.27
End Levee Mile	0.27
Location	Land Side
Category	
Item	Encroachments

View of tree branches located on the landside slope of the levee looking upstream during spring 2013 inspection.

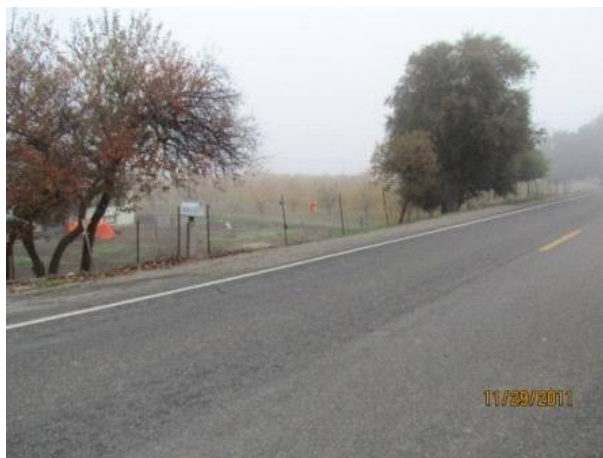
Levee Mile Report Line	7
Start Levee Mile	0.34
End Levee Mile	0.34
Location	Land Side
Category	
Item	Encroachments
Fence was found on the landside of the levee looking upstream.	
pkazi_s_20130304_530.jpg

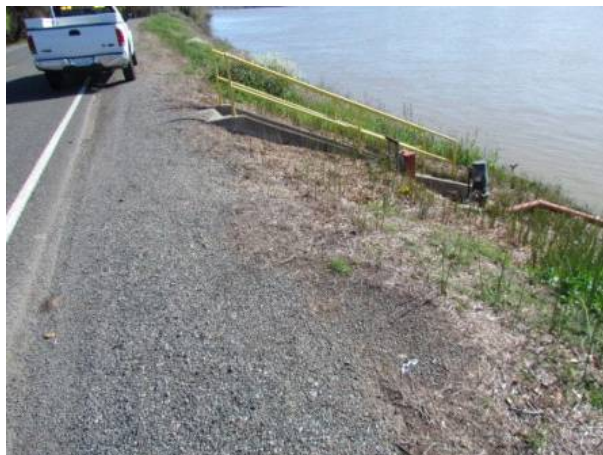
Levee Mile Report Line	9
Start Levee Mile	0.40
End Levee Mile	0.40
Location	Water Side
Category	
Item	Slope Stability
Slope instability was found on the waterside of the levee looking upstream.	
pkazi_s_20130304_526.jpg

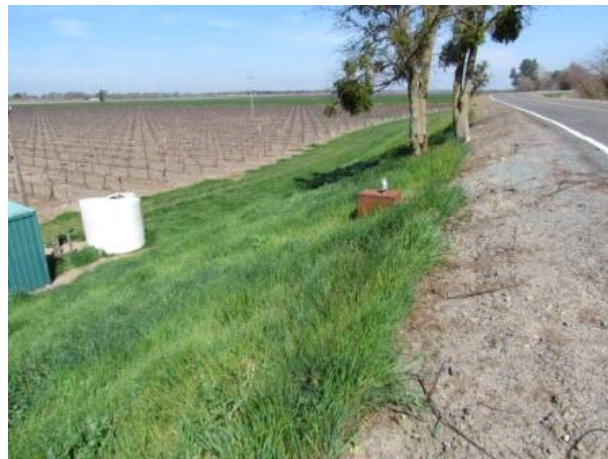
pkazi\_s\_20130319\_902.JPG

Vegetation was found on the landside of the levee looking upstream during spring 2013 inspection.

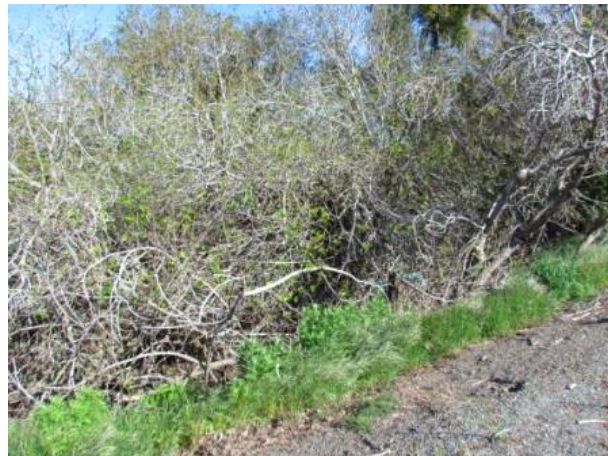
Levee Mile Report Line	14
Start Levee Mile	0.98
End Levee Mile	0.98
Location	Land Side
Category	
Item	Trim / Thin Trees

Overgrown trees were obstructing the landside slope of the levee looking upstream.

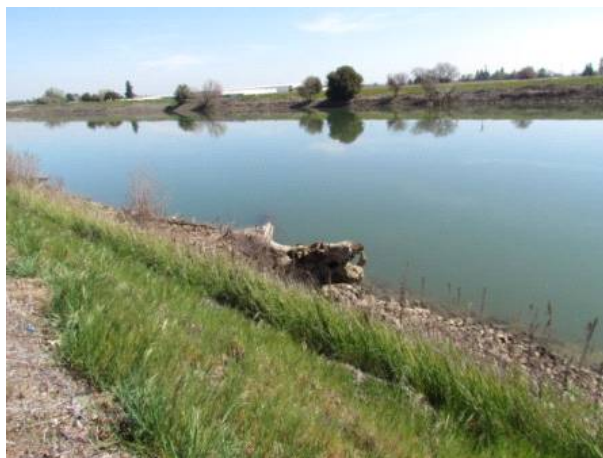
pkazi\_s\_20130319\_903.JPG

A tree trunk was found on the waterside toe of the levee looking downstream during spring 2013 inspection.

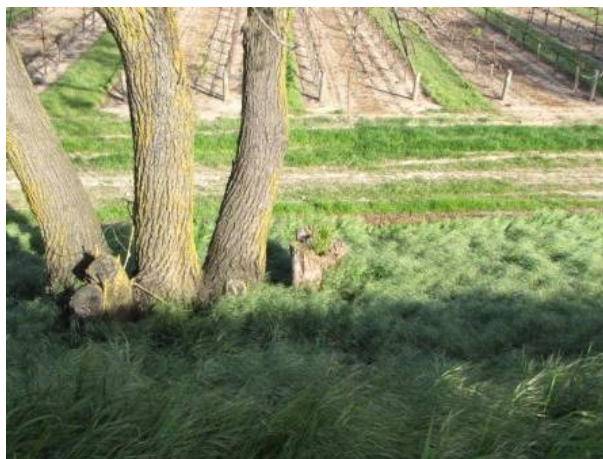
Levee Mile Report Line	16
Start Levee Mile	1.16
End Levee Mile	1.16
Location	Land Side
Category	
Item	Trim / Thin Trees

View of a tree stump on the landward slope.

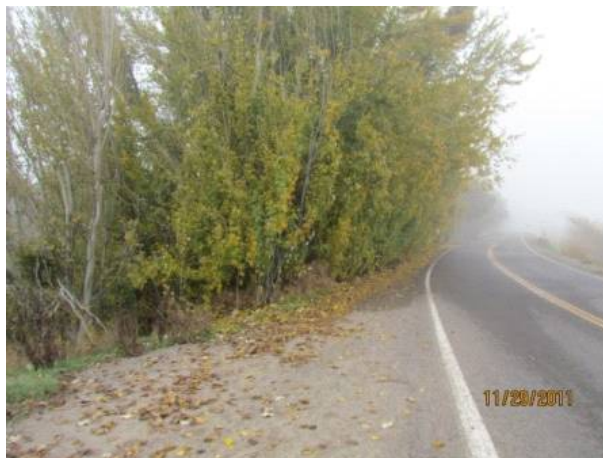
Levee Mile Report Line	18
Start Levee Mile	1.34
End Levee Mile	1.37
Location	Land Side
Category	
Item	Vegetation

Landscaping was found landside of the levee looking upstream.

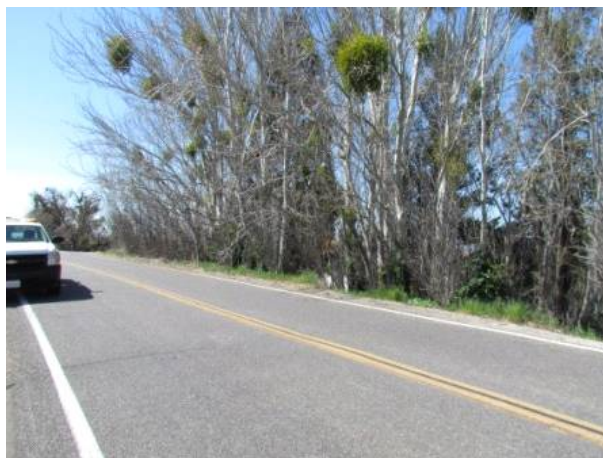
pkazi\_s\_20130319\_904.JPG

Landscaping was obstructing the view of the landside slope of the levee looking downstream. This picture was taken during spring 2013 inspection.

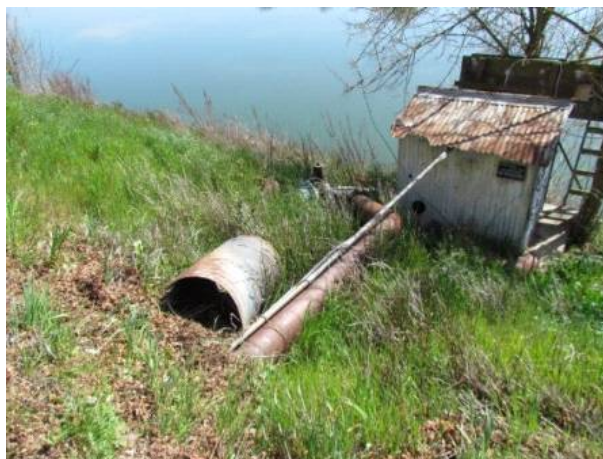
Levee Mile Report Line	19
Start Levee Mile	1.58
End Levee Mile	1.58
Location	Water Side
Category	
Item	Encroachments

Debris was found on the waterside slope of the levee looking upstream during spring 2013 inspection.

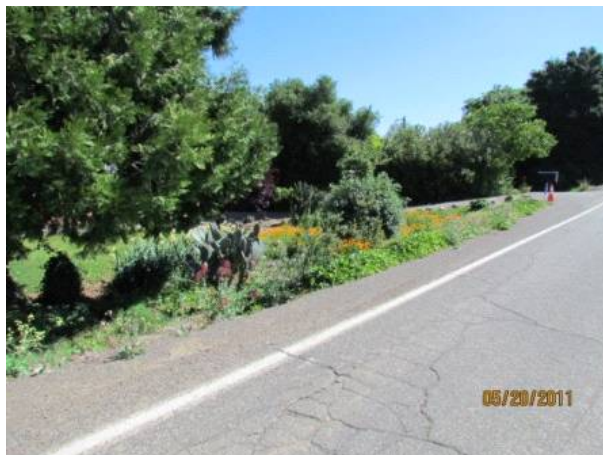
Levee Mile Report Line	21
Start Levee Mile	2.31
End Levee Mile	2.33
Location	Land Side
Category	
Item	Vegetation

Landscaping was found on the landside of the levee. The picture was taken from the crown looking upstream.

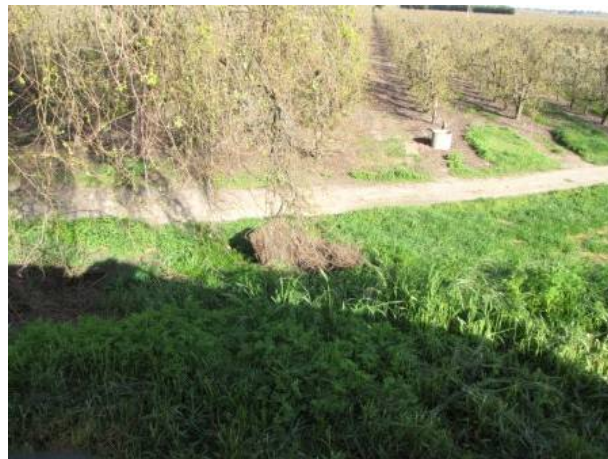
Levee Mile Report Line	23
Start Levee Mile	2.80
End Levee Mile	2.80
Location	Land Side
Category	
Item	Trim / Thin Trees
View of a tree stump on the landward slope.	
pkazi_s_20130304_533.jpg

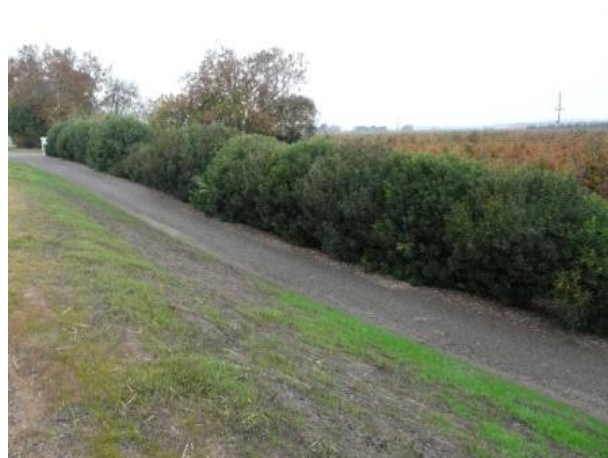
Levee Mile Report Line	25
Start Levee Mile	3.02
End Levee Mile	3.06
Location	Land Side
Category	
Item	Vegetation
Landscaping providing a screen for a residence on landside of levee from LM 3.02 to LM 3.06	
pkazi_s_20130304_563.JPG

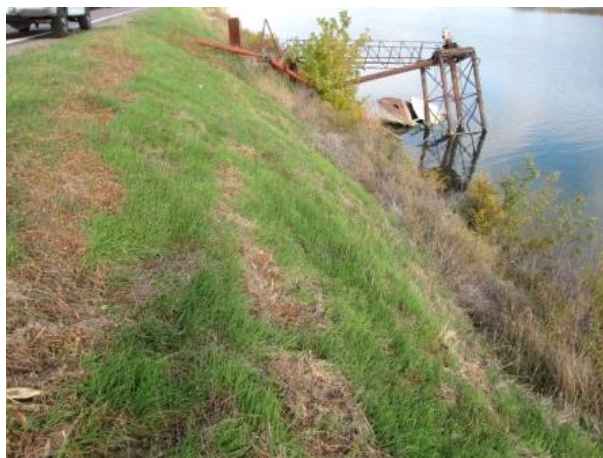
pkazi\_s\_20130304\_568.jpg

View of erosion on the waterward slope looking upstream. Depressions into the slope can be seen in several places.

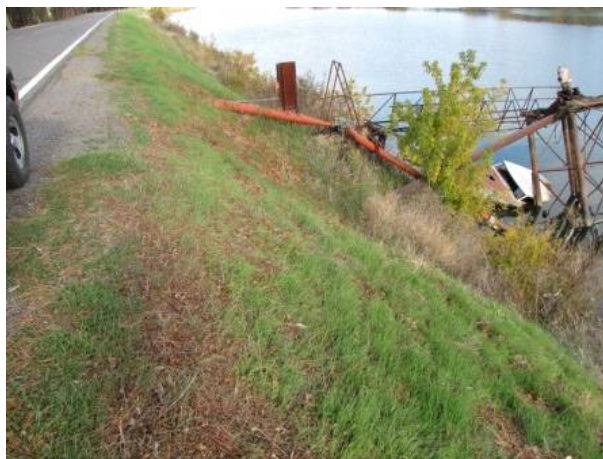
Levee Mile Report Line	26
Start Levee Mile	3.29
End Levee Mile	3.29
Location	Water Side
Category	
Item	Erosion / Bank Caving

Additional view of erosion on the waterward slope looking upstream. Note the damaged pump support, pump, and pipe just upstream of the site.

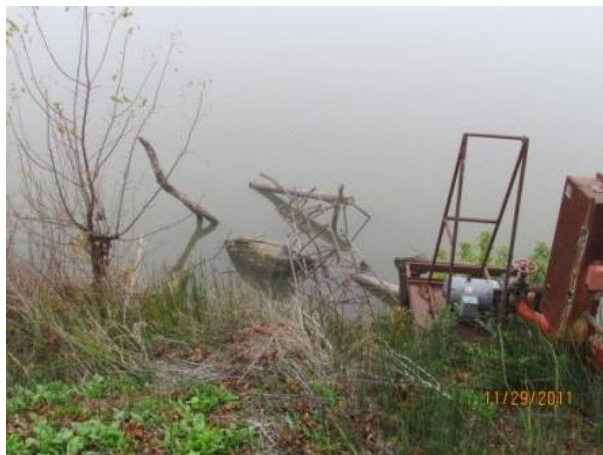
Levee Mile Report Line	26
Start Levee Mile	3.29
End Levee Mile	3.29
Location	Water Side
Category	
Item	Erosion / Bank Caving

View of the erosion site, and broken pump support along with a boat on the waterside of the levee. The picture was taken from the crown looking towards the toe of the levee during fall 2011 inspection.

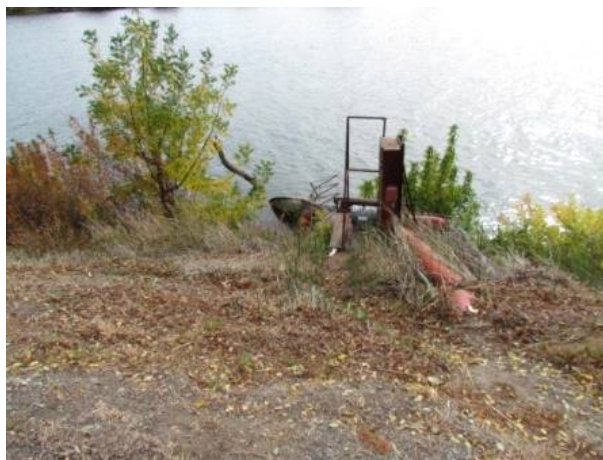
pkazi\_s\_20130304\_571.jpg

View of erosion and damaged pipe and abandoned boat on the waterside of the levee looking upstream. This picture was taken during fall 2012 inspection.

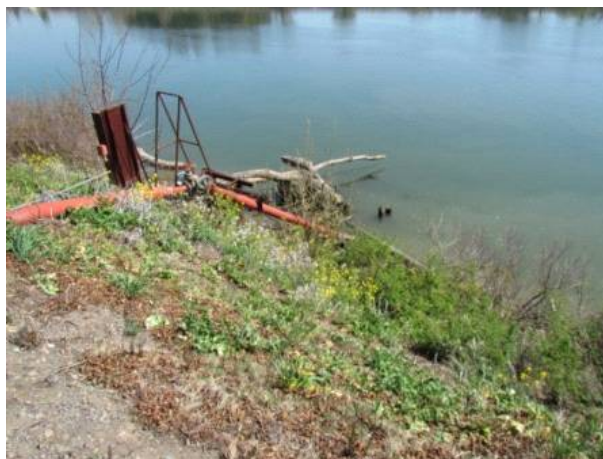
Levee Mile Report Line	26
Start Levee Mile	3.29
End Levee Mile	3.29
Location	Water Side
Category	
Item	Erosion / Bank Caving

View of the erosion on the waterside slope of the levee looking upstream during spring 2013 inspection.

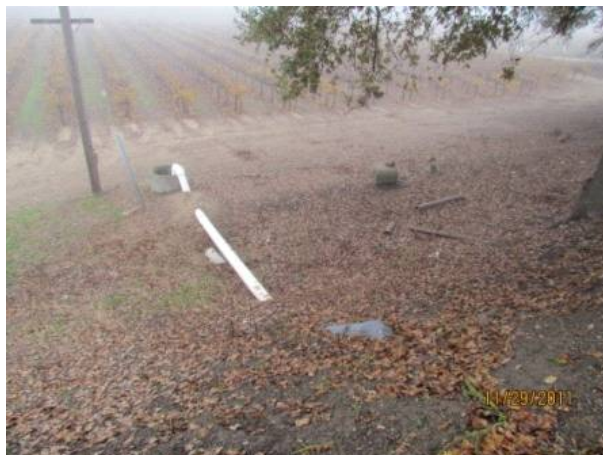
Levee Mile Report Line	28
Start Levee Mile	3.56
End Levee Mile	3.56
Location	Crown
Category	
Item	Encroachments

A PVC pipe was used under the levee crown for irrigation purpose. The picture was taken from the crown looking downstream.

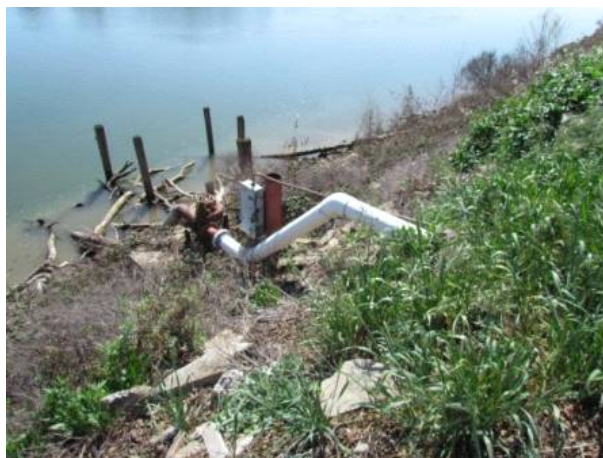
pkazi\_s\_20130320\_908.JPG

A PVC pipe was used to pump the water from waterside of the levee. It appeared that the PVC pipe was penetrating through a corroded steel casing through the levee crown. The picture was taken from the crown of the levee looking upstream during spring 2013 inspection.

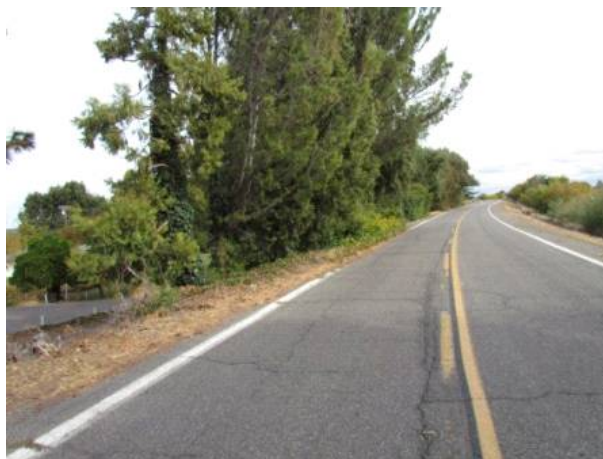
Levee Mile Report Line	29
Start Levee Mile	3.60
End Levee Mile	3.73
Location	Land Side
Category	
Item	Vegetation

Landscaping was blocking the visibility on the landside of the levee looking upstream.

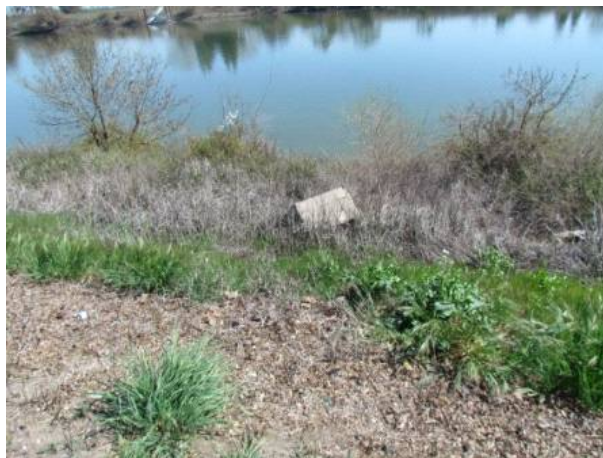
Levee Mile Report Line	30
Start Levee Mile	3.85
End Levee Mile	3.85
Location	Water Side
Category	
Item	Encroachments

Debris was found on the waterside toe of the levee looking upstream during spring 2013 inspection.

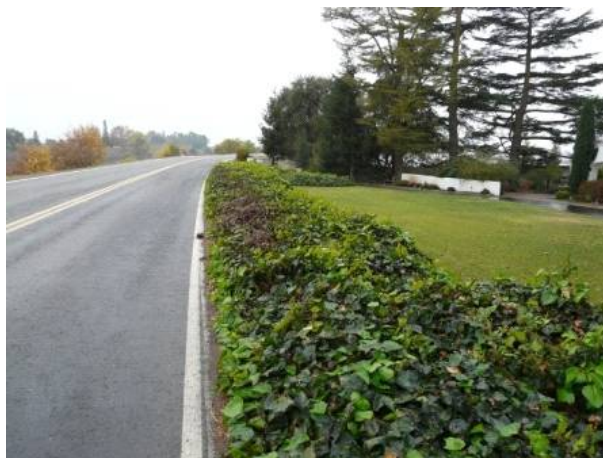
pkazi\_s\_20130304\_561.JPG

Landscaping in front of a residence on landside of levee from LM 3.90 to LM 3.93. The levee in this location is greater than 100' wide.

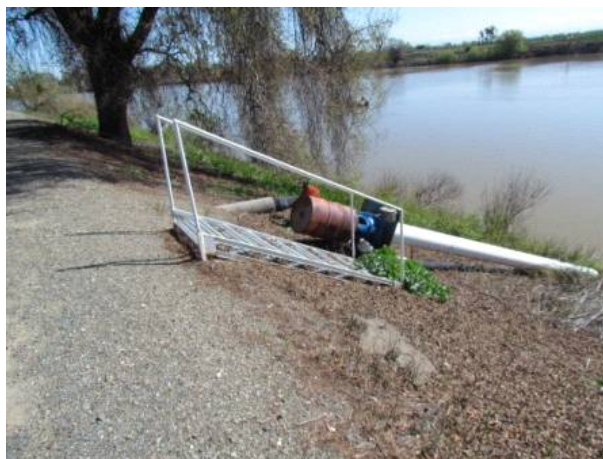
Levee Mile Report Line	32
Start Levee Mile	3.94
End Levee Mile	3.94
Location	Water Side
Category	
Item	Encroachments

A stairway was found on the waterside slope of the levee.

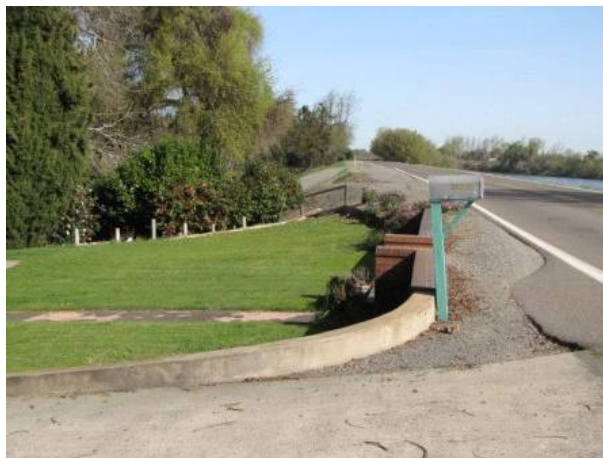
Levee Mile Report Line	33
Start Levee Mile	4.15
End Levee Mile	4.16
Location	Land Side
Category	
Item	Encroachments

View of a retaining wall on the landward slope looking upstream.

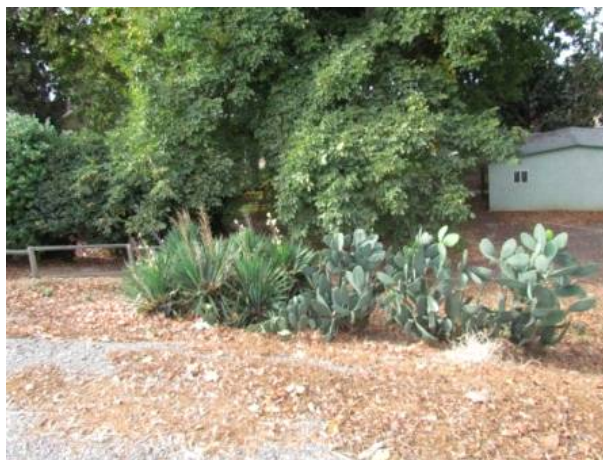
pkazi\_s\_20130304\_567.jpg

View of cacti on the landside of the levee looking from the crown.

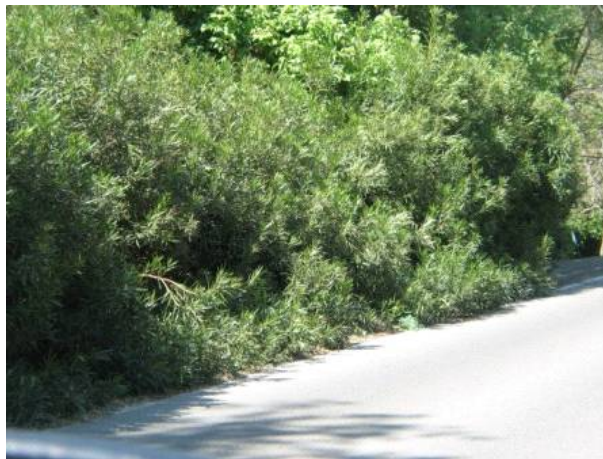
Levee Mile Report Line	36
Start Levee Mile	4.33
End Levee Mile	4.35
Location	Land Side
Category	
Item	Vegetation

Landscaping (Oleander) on landward slope from 4.33 to 4.35

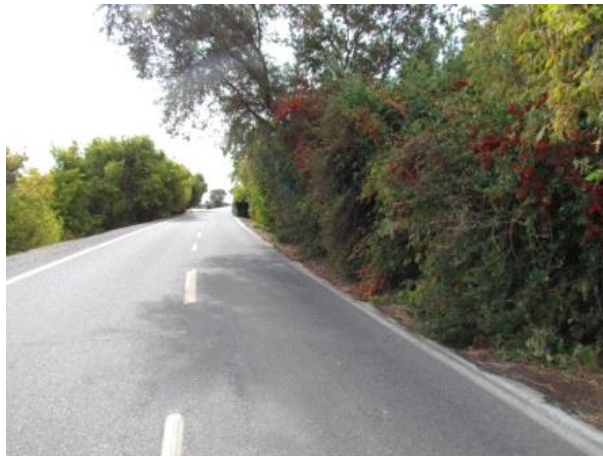
Levee Mile Report Line	37
Start Levee Mile	4.37
End Levee Mile	4.41
Location	Land Side
Category	
Item	Vegetation

Trees were obstructing the views on the landside slope of the levee looking downstream.

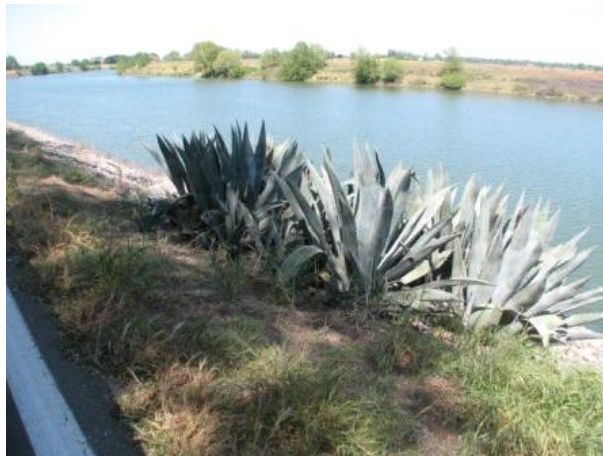
Levee Mile Report Line	40
Start Levee Mile	4.76
End Levee Mile	4.76
Location	Water Side
Category	
Item	Vegetation

Century plant on waterward slope at LM 4.76

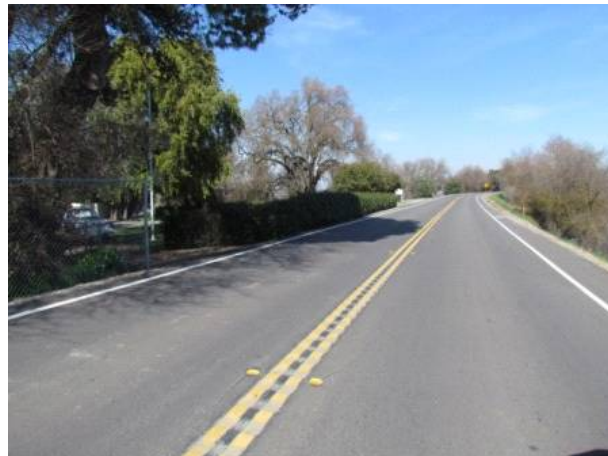
pkazi\_s\_20130320\_910.JPG

Landscaping was found on the landside shoulder of the levee looking upstream.

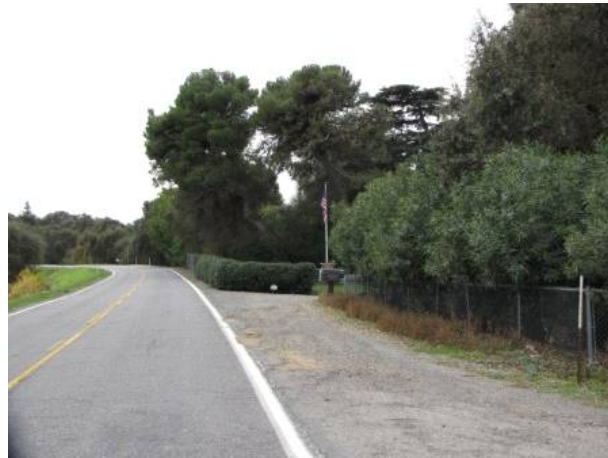
pkazi\_s\_20130304\_558.jpg

View of landscaping along the landward shoulder and slope looking downstream.

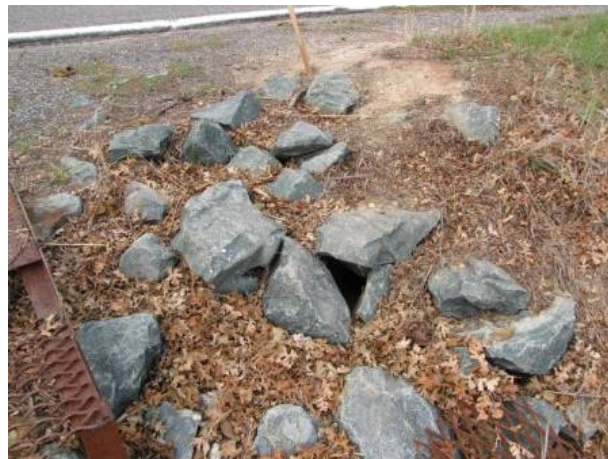
Levee Mile Report Line	47
Start Levee Mile	5.33
End Levee Mile	5.33
Location	Water Side
Category	
Item	Slope Stability

View of rock placed on a pipe penetration on the waterward slope. Cavities can be seen under the rocks.

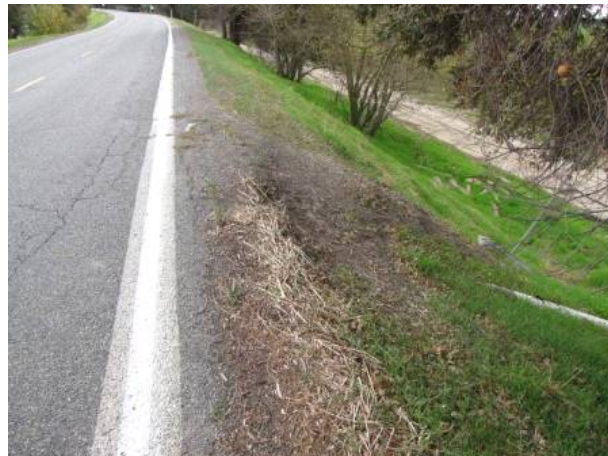
pkazi\_s\_20130304\_573.jpg

View of a minor depression along the landward slope of the levee over a pipe penetration looking downstream.

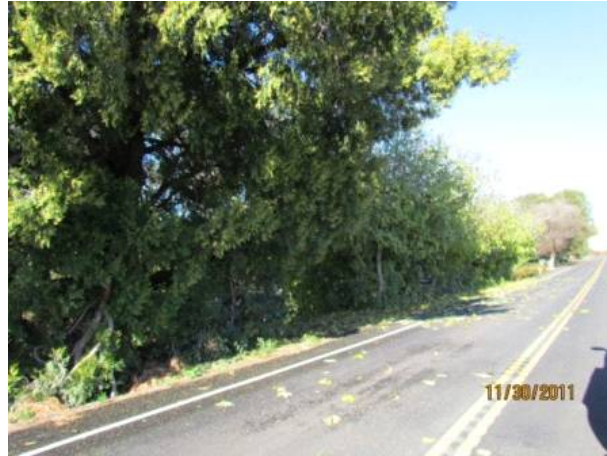
pkazi\_s\_20130304\_543.jpg

Trees need to be trimmed on the landside of the levee looking upstream.

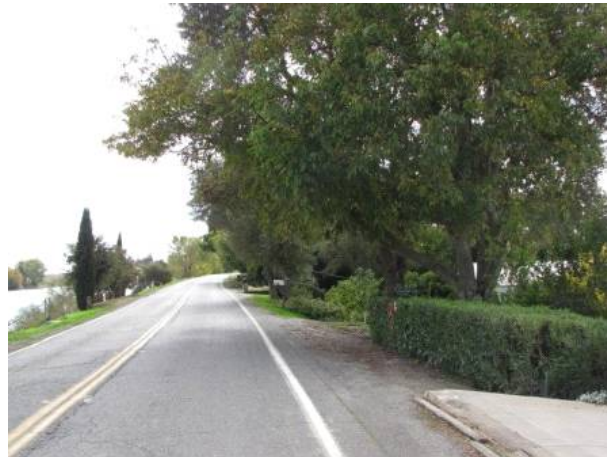
pkazi\_s\_20130304\_557.jpg

View of landscaping along the waterward shoulder and slope looking downstream.

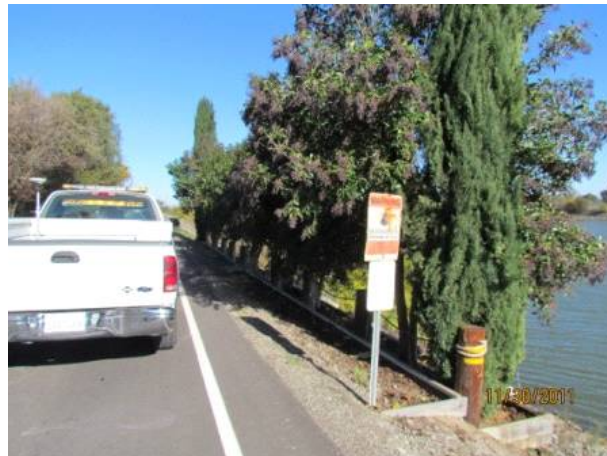
pkazi\_s\_20130304\_545.jpg

Landscaping was found on the waterside of the levee looking upstream.

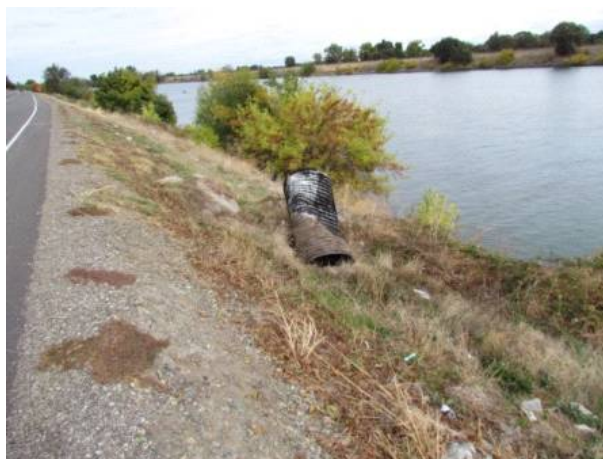
Levee Mile Report Line	58
Start Levee Mile	6.60
End Levee Mile	6.60
Location	Water Side
Category	
Item	Encroachments
Debris was found on the waterside slope of the levee looking upstream.	
pkazi_s_20130304_524.jpg

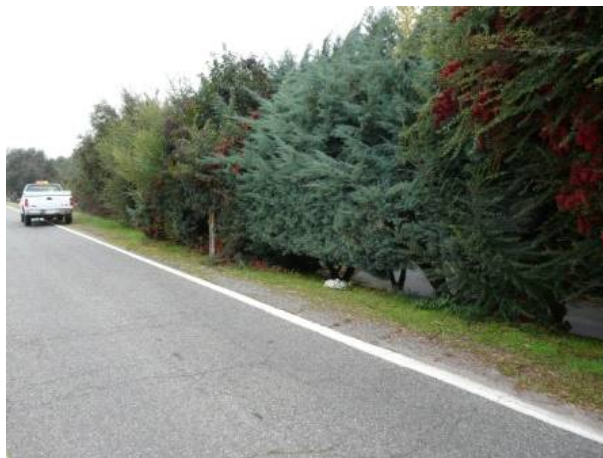
Levee Mile Report Line	59
Start Levee Mile	6.67
End Levee Mile	6.72
Location	Land Side
Category	
Item	Vegetation
Landscaping providing a screen for a residence on landside of levee from LM 6.68 to LM 6.72	
pkazi_s_20130304_556.JPG

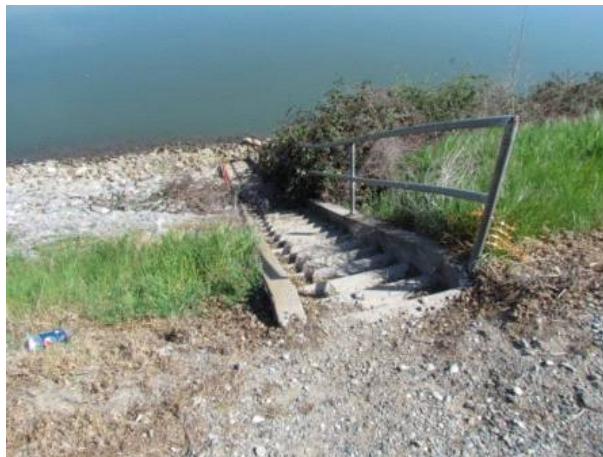
pkazi\_s\_20130320\_912.JPG

A stair was found on the waterside slope of the levee looking upstream during spring 2013 inspection.

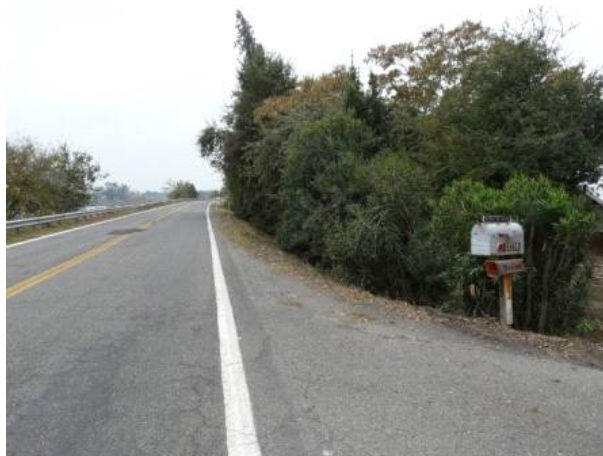
pkazi\_s\_20130304\_555.JPG

Landscaping providing a screen for a residence on the landside of levee from LM 6.93 to LM 7.05

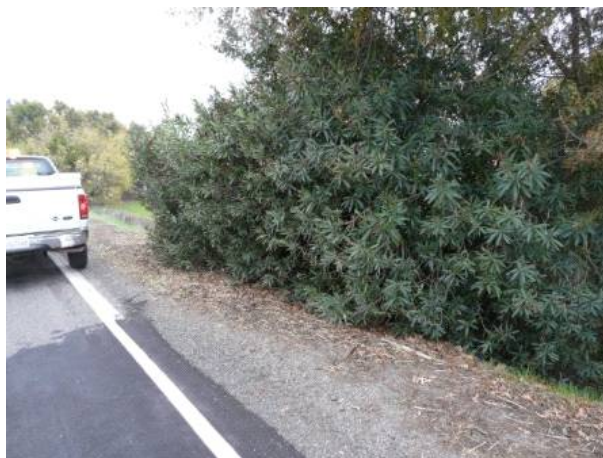
pkazi\_s\_20130304\_554.JPG

Landscaping providing a screen for a residence on landside of levee at LM 7.12

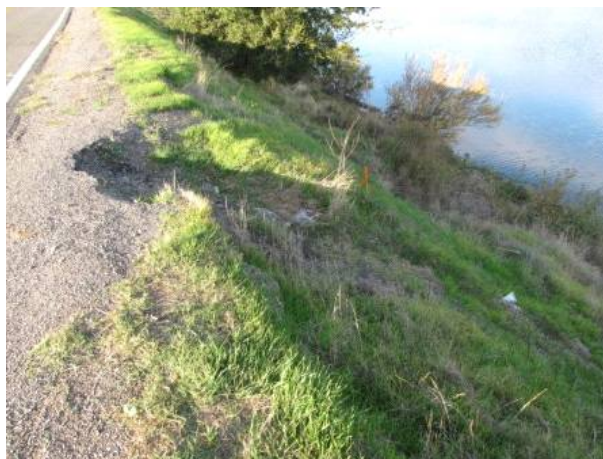
pkazi\_s\_20130304\_572.jpg

View of minor erosion along the top portion of the waterward slope likely cause by foot traffic. The erosion has started to encroach into the shoulder of the road.

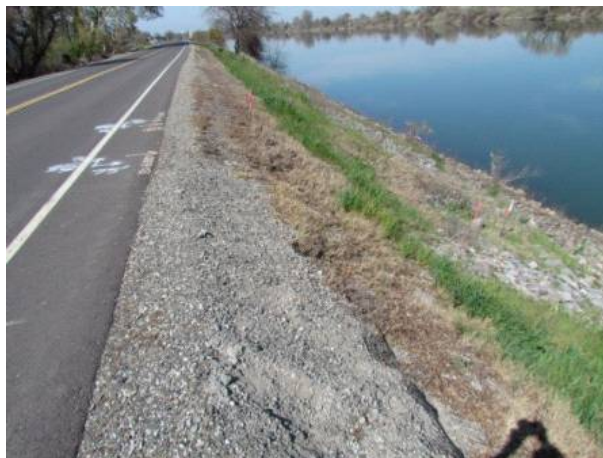
pkazi\_s\_20130320\_913.JPG

View of minor erosion on the waterside slope of the levee looking upstream during spring 2013 inspection.

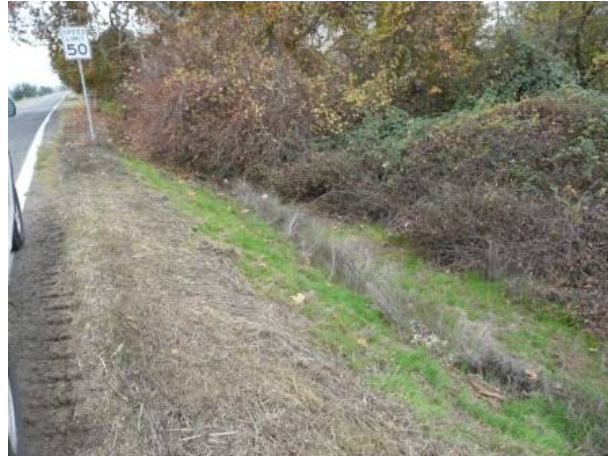
Levee Mile Report Line	66
Start Levee Mile	7.36
End Levee Mile	7.41
Location	Land Side
Category	
Item	Trim / Thin Trees
Trim/thin trees and brush on landside of levee from LM 7.36 to LM 7.41	
pkazi_s_20130304_550.JPG

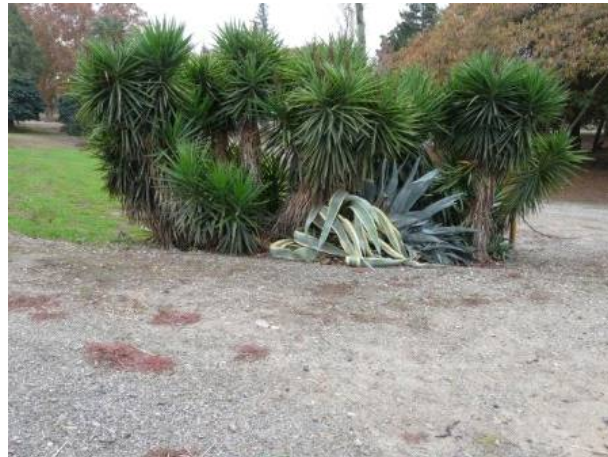
Levee Mile Report Line	68
Start Levee Mile	7.92
End Levee Mile	7.92
Location	Land Side
Category	
Item	Vegetation
Landscaping on landside of levee at LM 7.92	
pkazi_s_20130304_553.JPG

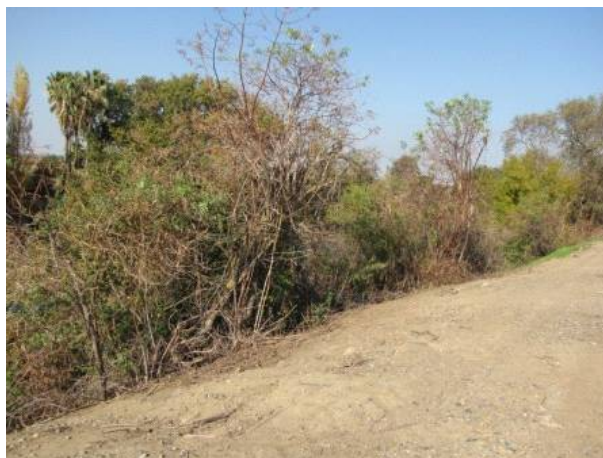
pkazi\_s\_20130304\_669.jpg

View of elderberry bush within 20 feet of shoulder blocking visibility and access.

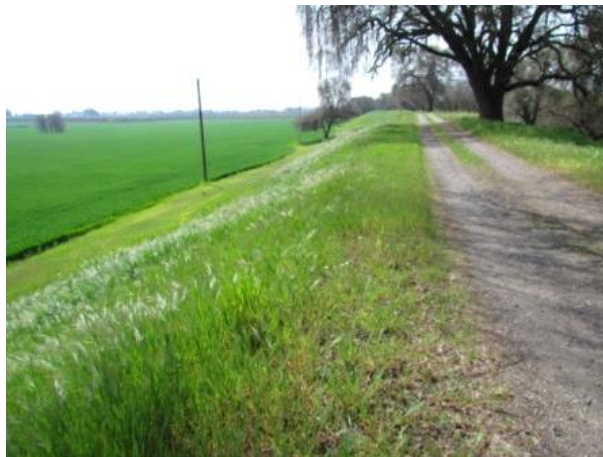
pkazi\_s\_20130320\_915.JPG

Vegetation was found on the landside slope of the levee looking upstream.

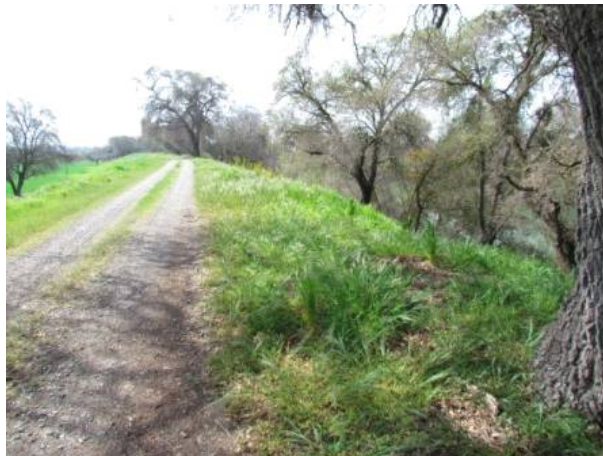
pkazi\_s\_20130320\_914.JPG

Vegetation was found on the waterside slope of the levee looking downstream during spring 2013 inspection.

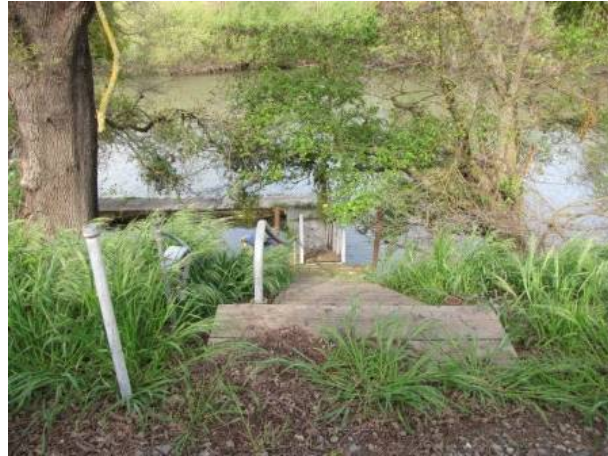
pkazi\_s\_20130304\_577.jpg

View of steps, a dock, and associated utilities on the waterward slope.

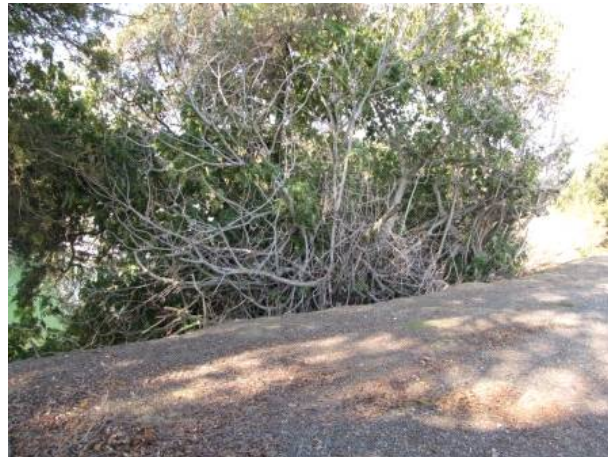
pkazi\_s\_20130304\_670.jpg

View of trees and bushes within 20 feet of the shoulder blocking visibility and access.

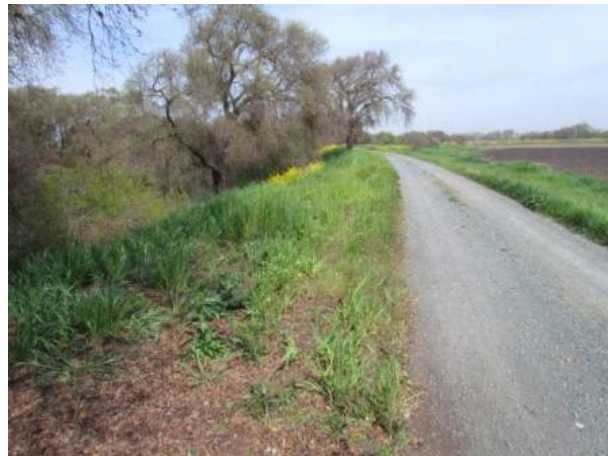
pkazi\_s\_20130320\_916.JPG

Vegetation was found on the waterside slope of the levee looking upstream during spring 2013 inspection.

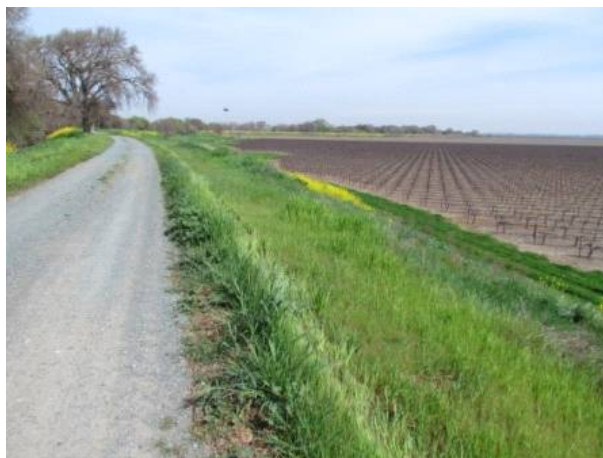
pkazi\_s\_20130320\_917.JPG

Vegetation was found on the landside slope of the levee looking upstream during spring 2013 inspection.

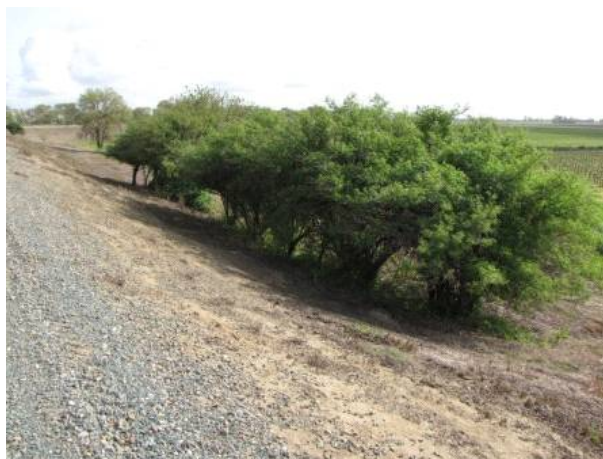
pkazi\_s\_20130304\_579.jpg

View of elderberries on the landward slope blocking visibility and access.

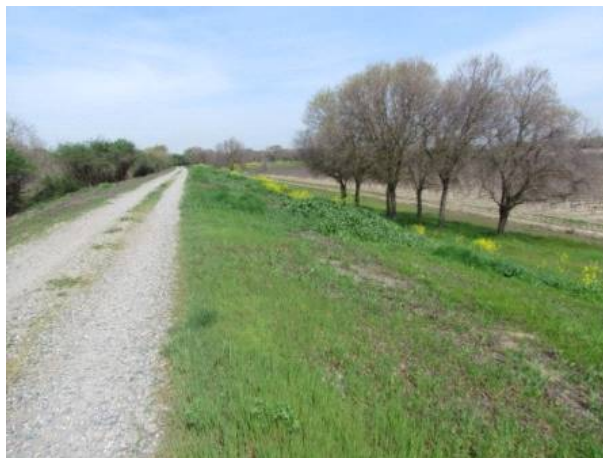
pkazi\_s\_20130320\_918.JPG

Vegetation was found on the landside slope of the levee looking upstream during spring 2013 inspection.

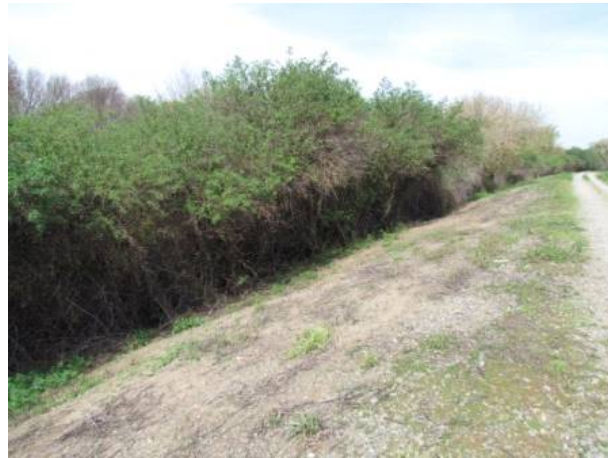
pkazi\_s\_20130320\_919.JPG

Trees were completely blocking the visibility on the waterside slope of the levee looking upstream during spring 2013 inspection.

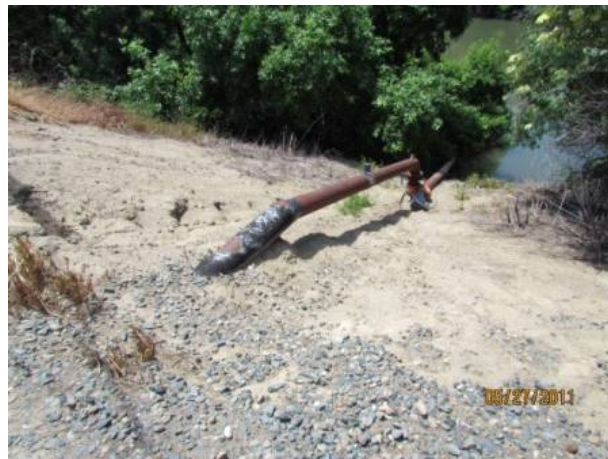
pkazi\_s\_20130304\_615.jpg

Erosion was found on the waterside slope of the levee near the vicinity of the pipe. The picture was taken from the crown looking downstream.

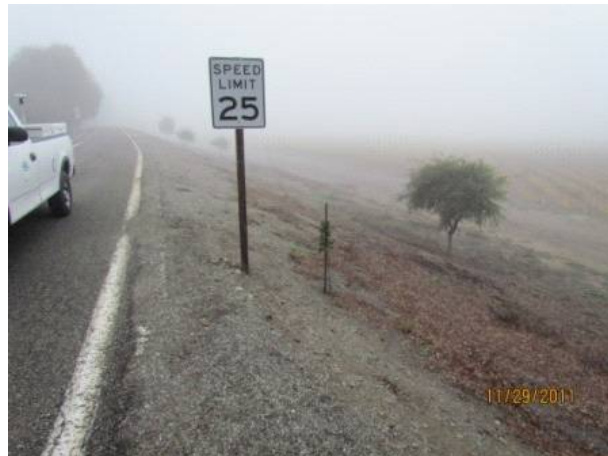
pkazi\_s\_20130304\_648.jpg

New tree has been planted on the landside slope of the levee looking upstream.

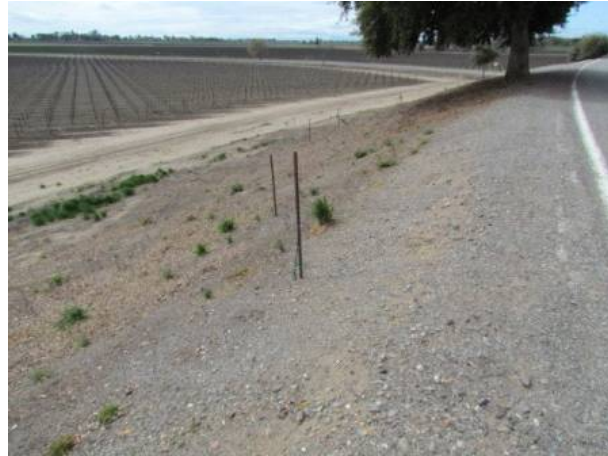
Levee Mile Report Line	14
Start Levee Mile	2.34
End Levee Mile	2.34
Location	Land Side
Category	
Item	Encroachments
New tree was planted on the landside of the levee looking downstream.	
pkazi_s_20130304_649.jpg

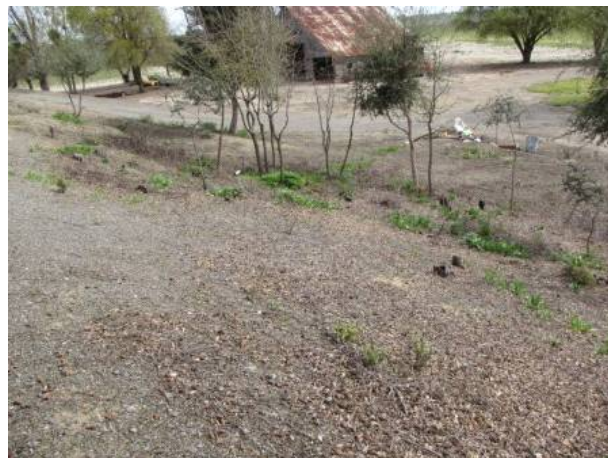
Levee Mile Report Line	15
Start Levee Mile	2.60
End Levee Mile	2.60
Location	Land Side
Category	
Item	Trim / Thin Trees
View of tree stumps on the landward slope.	
pkazi_s_20130304_583.jpg

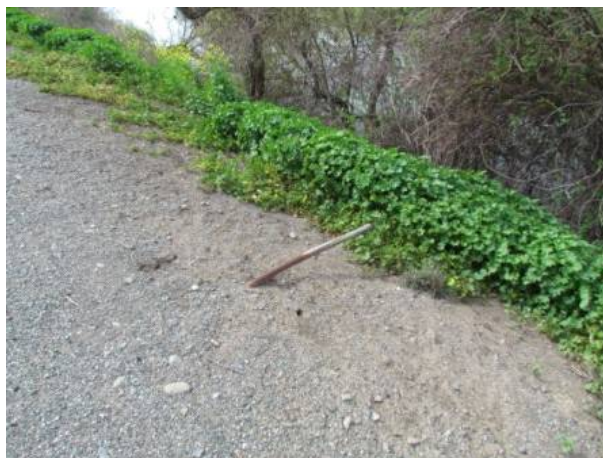
pkazi\_s\_20130320\_920.JPG

A pipe was found on the waterside shoulder of the levee looking downstream during spring 2013 inspection.

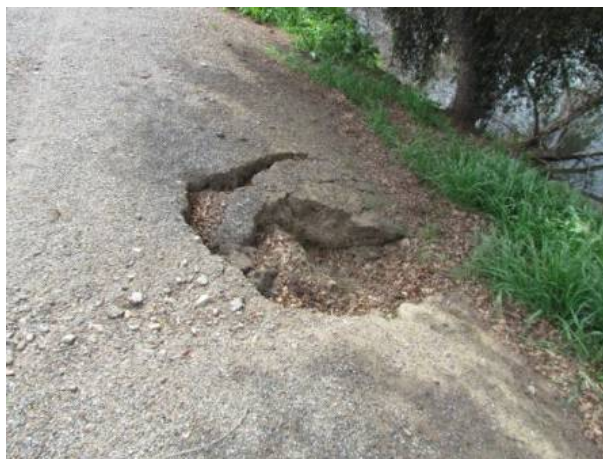
pkazi\_s\_20130320\_921.JPG

Erosion was found on the waterside slope of the levee looking downstream during spring 2013 inspection.

16	2.71	2.71		Encroachments	WS	M En	PI : Pipe	38.358406 ° -121.561300 °	38.358406 ° -121.561300 °	34 Y
								DWR ID: DWR_RD0150_03_s_2013_34		
17	2.86	2.86		Erosion / Bank Caving	WS	M Ma	E2 : Schedule repair of erosion site prior to the next inspection.	38.360432 ° -121.561644 °	38.360432 ° -121.561644 °	35 Y
								DWR ID: DWR_RD0150_03_s_2013_35		
18	2.87	2.87		Trim / Thin Trees	WS	N Ma	T5 : Tree stumps.	38.360621 ° -121.561762 °	38.360621 ° -121.561762 °	17 Y
								DWR ID: DWR_RD0150_03_s_2012_17		
19	2.93	2.93		Slope Stability	WS	M Ma	S1 : Repair slope instability.	38.361375 ° -121.562134 °	38.361375 ° -121.562134 °	76 Y
								DWR ID: DWR_RD0150_03_s_2012_76		
20	2.93	2.93		Crown Surface / Depressions / Rutting	CR	M Ma	C3 : Add appropriate gravel or road base. Grade and compact.	38.361375 ° -121.562135 °	38.361375 ° -121.562135 °	75 Y
								DWR ID: DWR_RD0150_03_s_2012_75		
21	3.13	3.13		Crown Surface / Depressions / Rutting	CR	C Ma	C3 : Add appropriate gravel or road base. Grade and compact.	38.363798 ° -121.560948 °	38.363798 ° -121.560948 °	22 Y

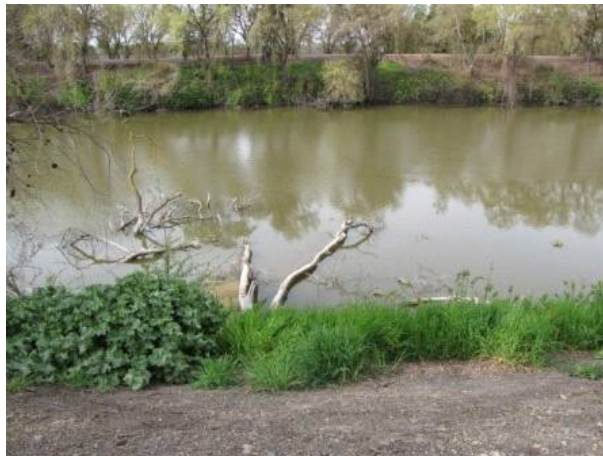
pkazi\_s\_20130304\_591.jpg

View of tree stumps on the waterward slope.

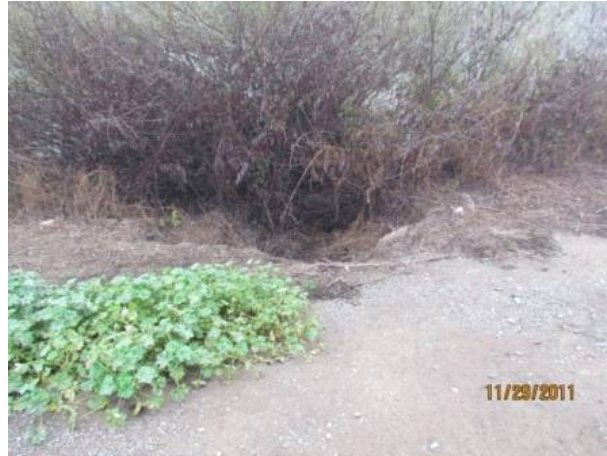
pkazi\_s\_20130304\_645.jpg

Slope instability was found on the waterside of the levee. The picture was taken from the crown looking towards the toe of the levee.

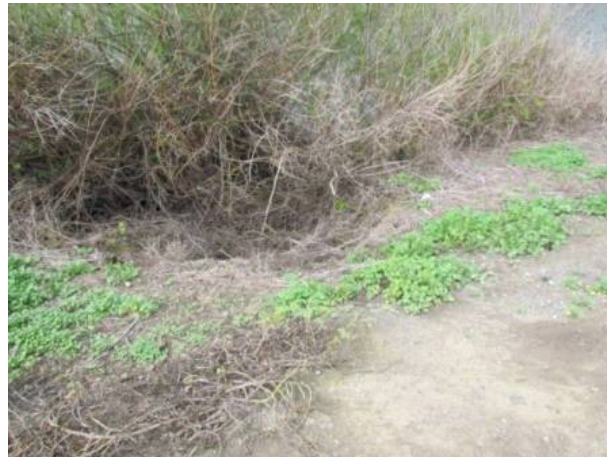
pkazi\_s\_20130304\_646.jpg

Erosion was found on the waterside of the levee looking upstream. This picture was taken during spring 2012 inspection.
